The *Mary Ellis* Report

Team 2

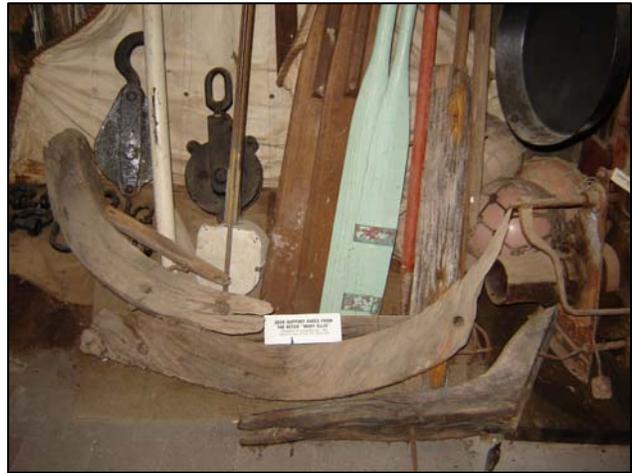
Figure 3. Deck knees and Frames from the *Mary Ellis* at the Axel Stenross Museum. Image: E. Jateff

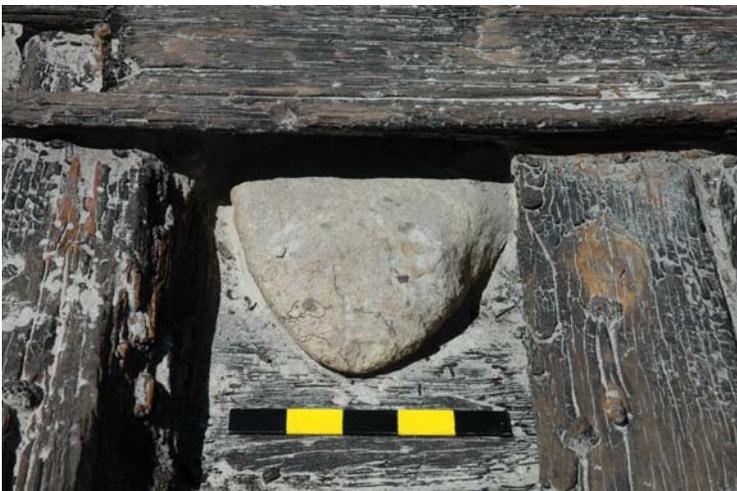
by Team 2 identified rocks (limestone) located between ceiling and hull planks (Figure 4) in one location. This statement backs up the Team assumption that Mary Ellis was, at one time, buried in a mix of limestone and sand.

Figure 5. *Mary Ellis*, limestone within frames. Image: E. Jateff

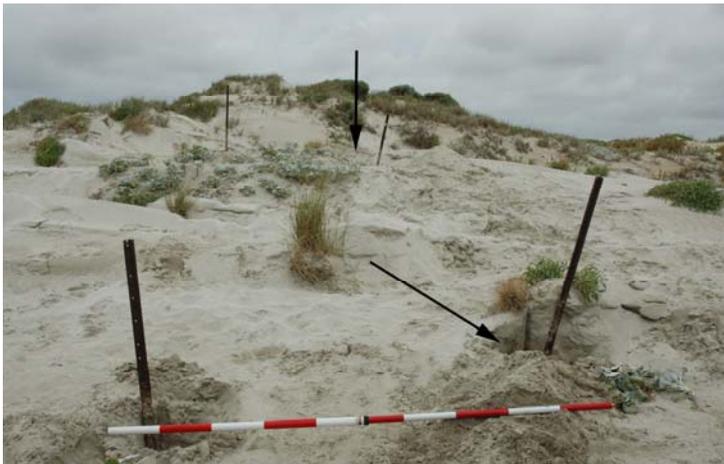
Figure 6 : The Mary Ellis buried pre-survey, (direction: southwest).

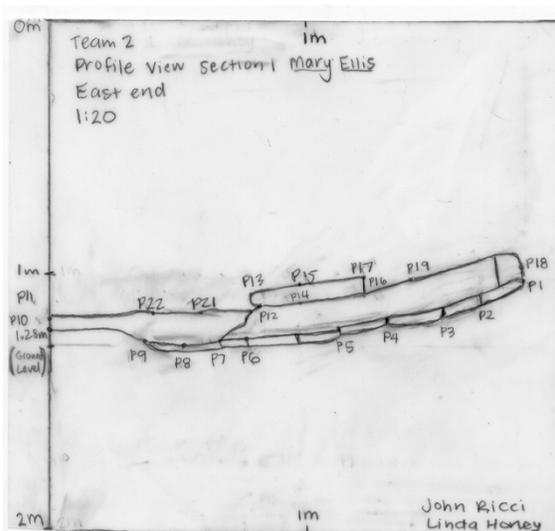
Figure 7 Profile of Section1 East End. J Ricci and L. Honey

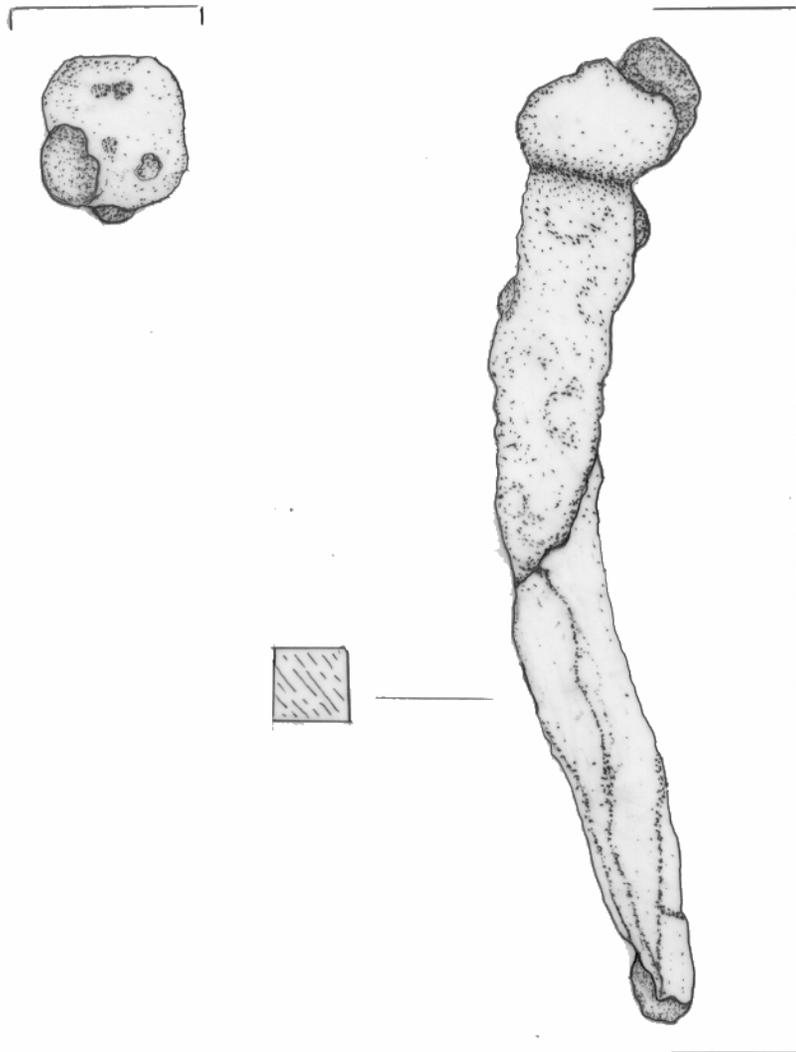
Example 1:

Only two artifacts were recovered, drawn, and reburied at the *Mary Ellis* wreck site. Both are samples of iron fasteners (Figures 4 and 5), and are presented at actual (true) size. The measurements for Example 1 are 127mm in length, 18mm for head width, and 10mm for thickness.

Figure 6. Iron Fastener from *Mary Ellis*. Image: Emily Jateff

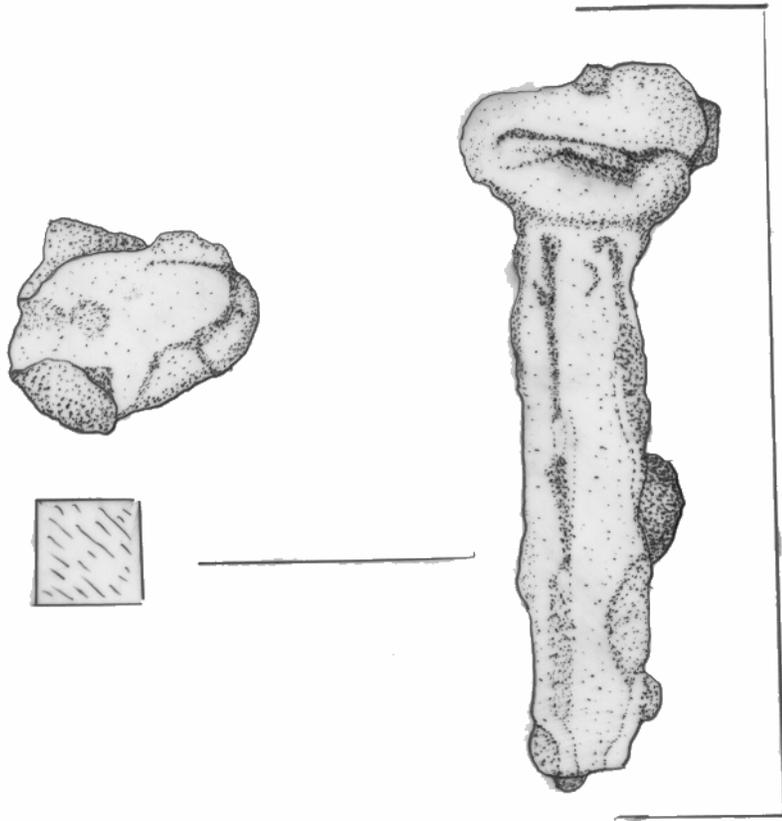
Example 2:

The measurements for Example 2 are 89mm in length, 33mm in head width, and 15mm in thickness.

Figure 7 . Iron Fastener Sample from *Mary Ellis*. Image: Emily Jateff
