Site Report

PS Ozone

Flinders University Maritime Archaeology Field

Portarlington 2008

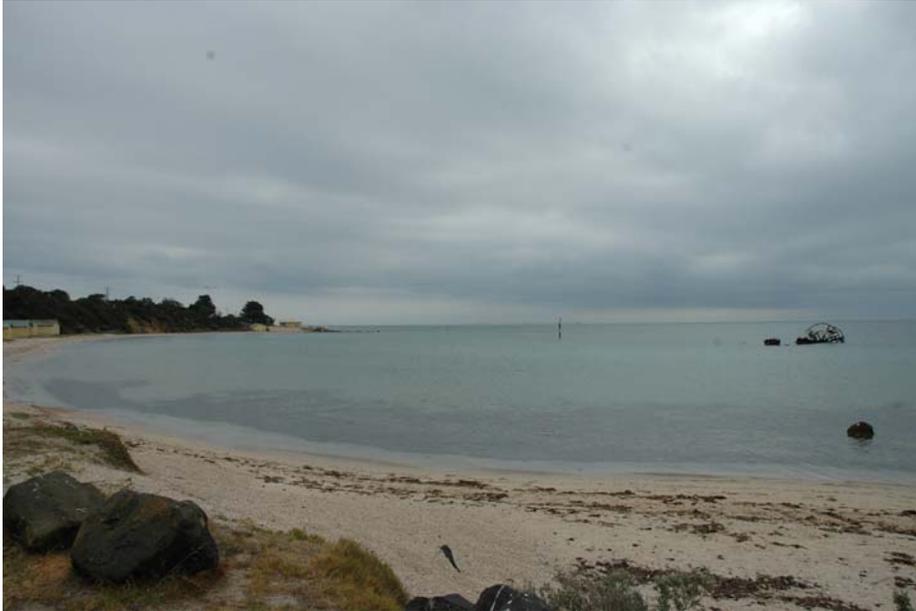
The PS Ozone is oriented with the stern to the NNW and bow to the SSE. Originally much of the wreck was above water; however it has deteriorated to the stage where only the port paddle wheel and a small amount of wheel support structure is still visible above water[Figure 1 – PS Ozone].

Figure 1 – PS Ozone in Half Moon Bay

It is suggested that measures to slow the deterioration of the existing paddlewheel are investigated to preserve the iconic status of this wreck for as long as possible. Additionally the information boards on the shore could be updated to indicate the fragile nature of the wreck and emphasise the hazards already alluded to for members of the public intent on climbing on or jumping from parts of the. A final recommendation is for Heritage Victoria to look into acquiring copies of the reports and documentation both published and unpublished of the Maritime Archaeology Association of Victoria (MAAV). Reference has been made in their 1996 project reports of extensive site survey work being performed. At present, this information does not appear to be currently available to researchers.

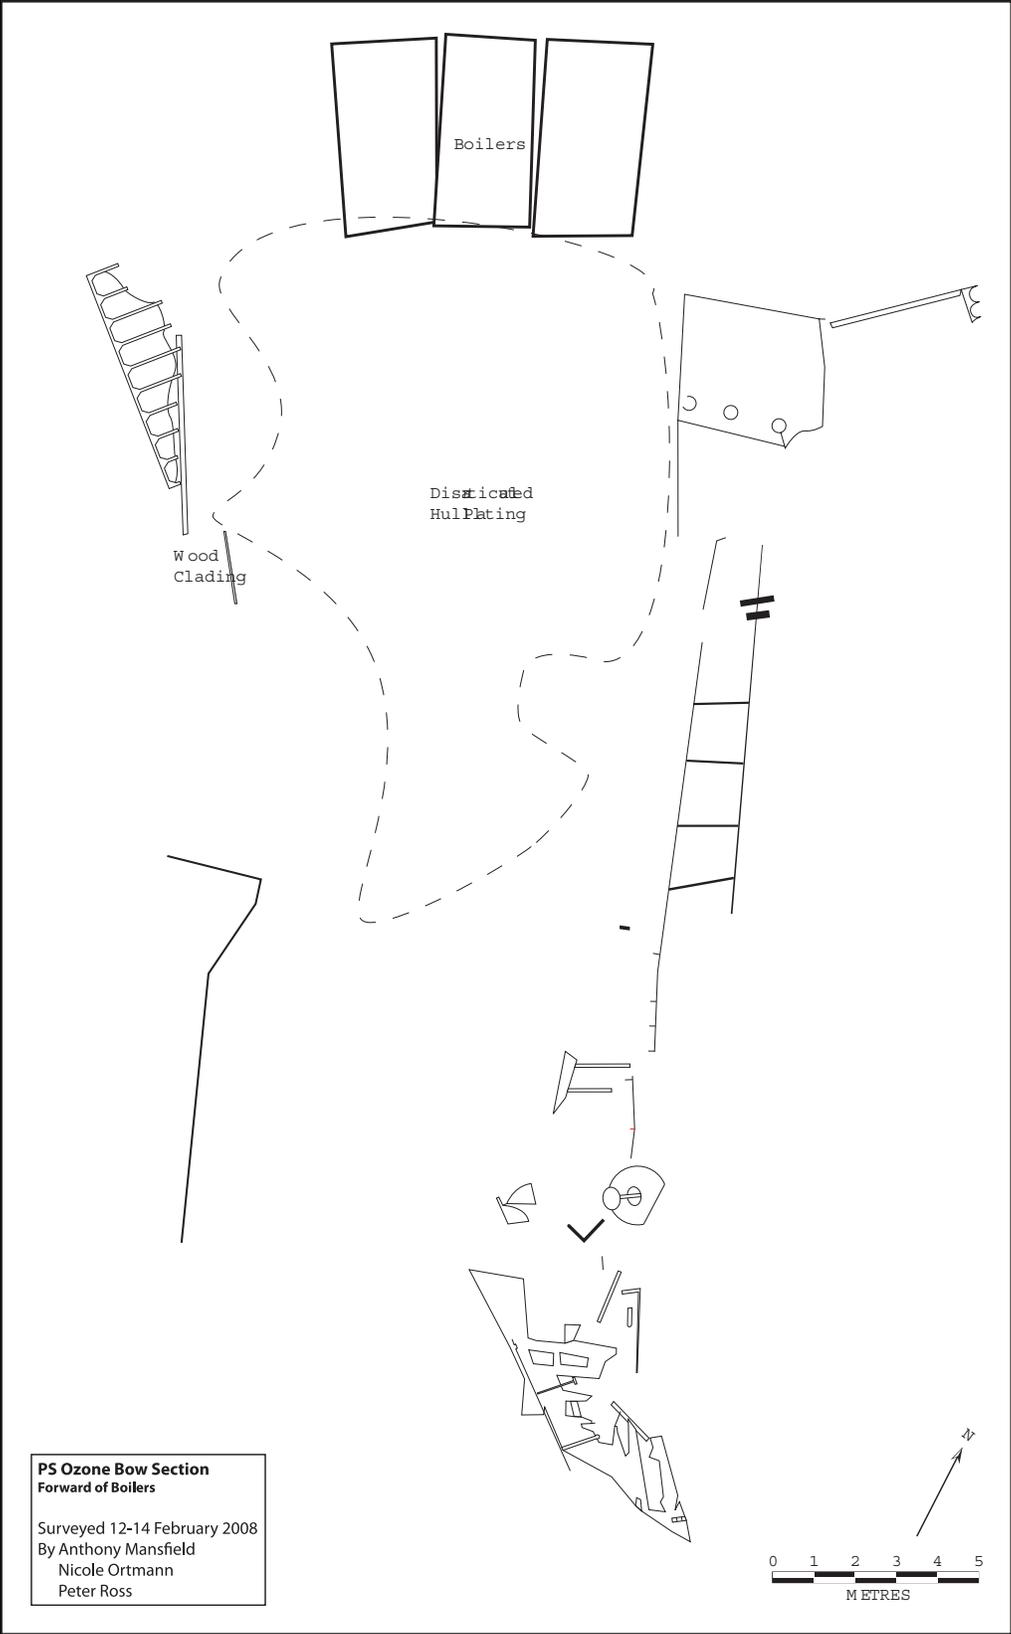
PS Ozone Bow Section
Forward of Boilers
Surveyed 12-14 February 2008
By Anthony Mansfield
Nicole Ortmann
Peter Ross

The primary result from this survey was the aggregated site plan produced. This shows the general layout of the forward section of the site and gives a number of good reference points for any future surveys to build upon, such as the boilers' forward faces and the bow section. The areas marked as "disarticulated hull plating" consist of multiple layers of hull frames and plating, liberally covered in marine growth. These areas would require days or possibly weeks of survey to record in any detail. Even photo surveys would not assist due to the plant life obscuring the underlying details.

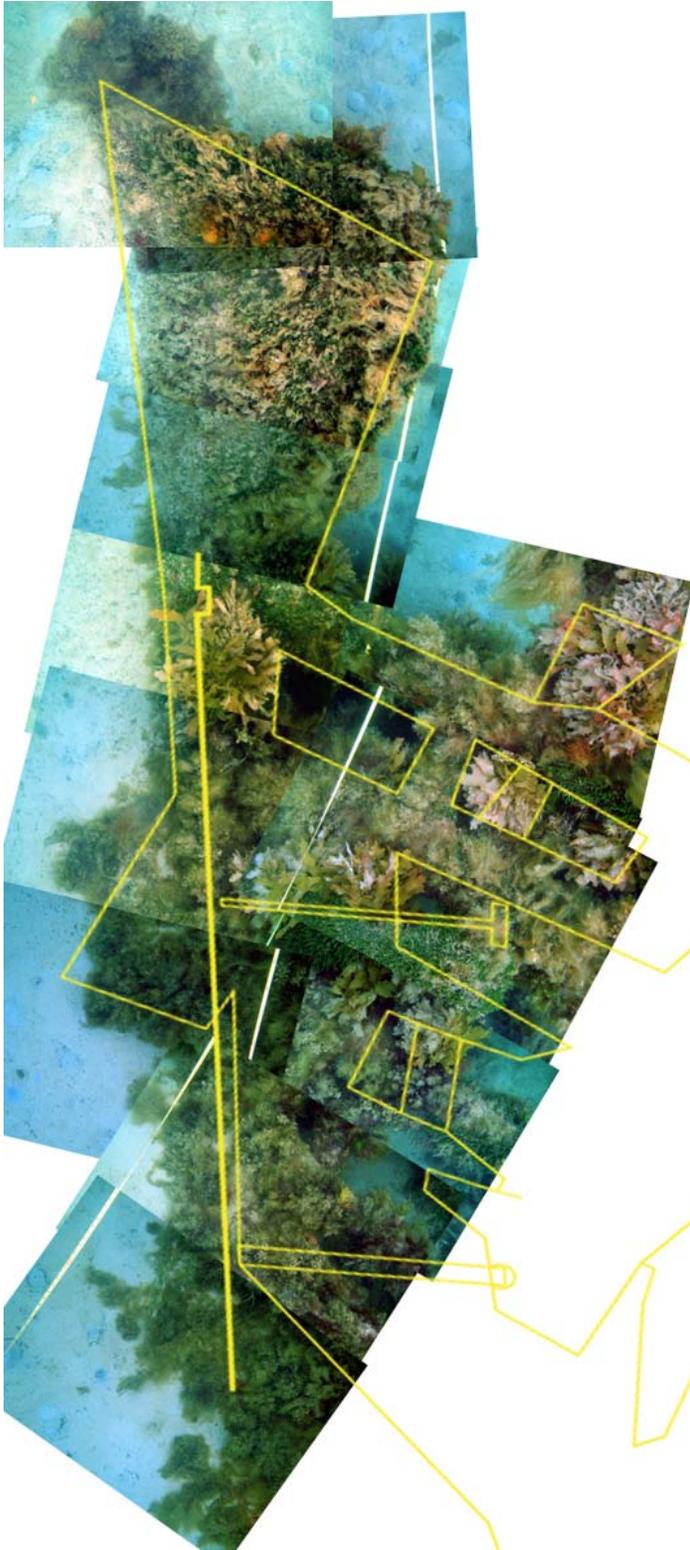
Figure 4 - Photo Mosaic of bow section

The photo mosaic does show the extent of marine growth over the wreck quite clearly.

The boilers are still mostly whole although they have shifted from their originally installed positions and now lie at slight angles to each other and the hull. The starboard paddlewheel collapsed in April 1991 and the port paddlewheel is mostly wasted away below the waterline. The bow triangle is still proud of the sand surface although further shell plating has decayed since the survey of 1997 by Geoff Hewitt.
