**Mount Dutton Bay Jetty**  
**Site Report**  
**February 2006**

Flinders University  
Maritime Archaeology  
Professor Mark Stanforth  
Arch 8103, Maritime field school

**Site Name:** Mount Dutton Bay Jetty, Mount Dutton Bay, South Australia

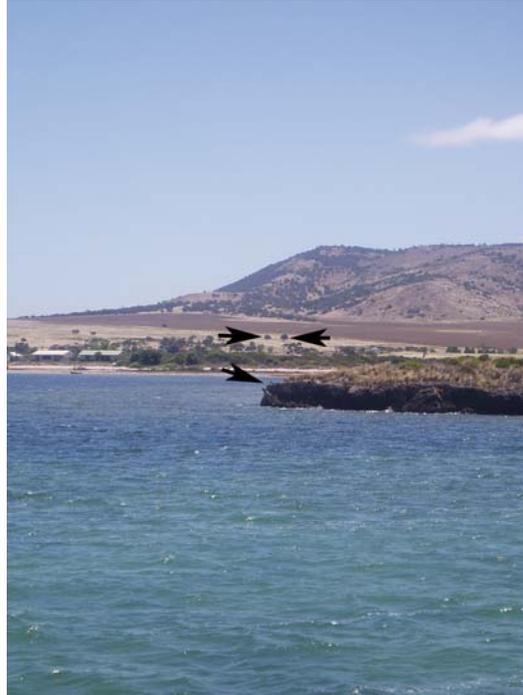
Figure 1. Transect visible from the Southern most extreme of the jetty site  
Photo by: B. Lockhart, 2006

Figure 1 shows the alignment of the shore in the foreground with the center of the trees in the background. This transect is located at a bearing of 340 degrees, and indicates the far extremity of the site boundary along the jetty (see figure 1 of the appendix for a site map). Figure 2 illustrates the alignment of the same shore in the foreground with the edge of the first house. This indicates the location of the Northern most portion of the site along the jetty. This transect is along a bearing of 330 degrees

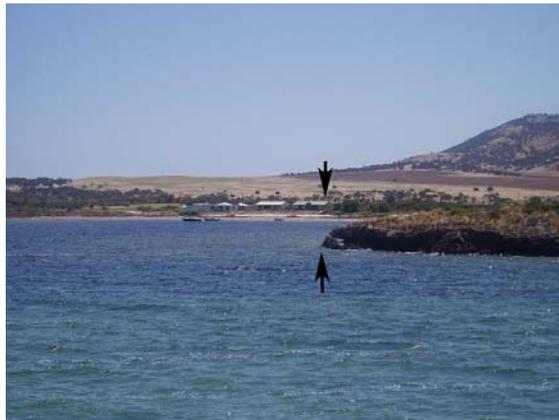
Figure 2. transect visible from the Northern most boundary of the site  
Photo by: B. Lockhart, 2006

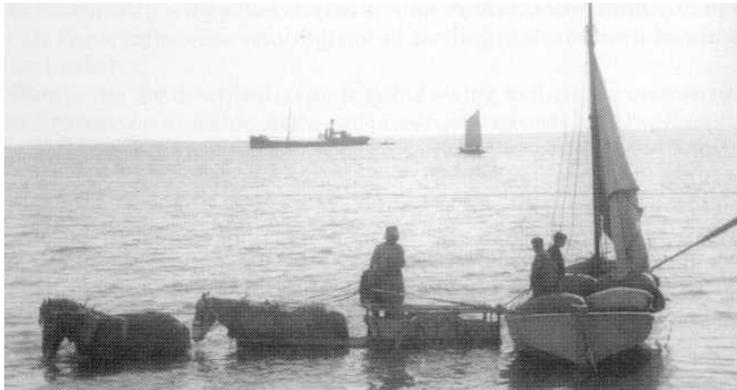
Figure 3. The lightering system used prior to the construction of the jetty (Khan 2006)  
This rapid growth put pressure on the lightering system. In 1880, possibly as a result of new lease acquisitions in 1877, plans were draughted for the construction of a jetty in immediate proximity to his shearing facility. It is uncertain whether construction was

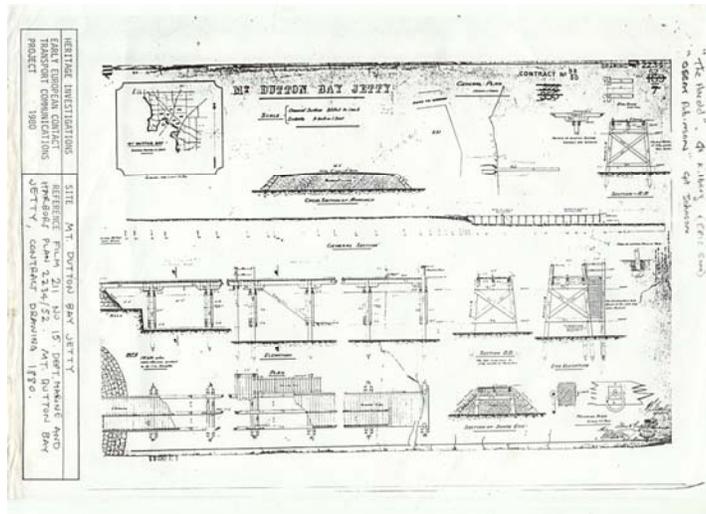
Figure 4. Mount Dutton Bay Jetty contract drawing, see also appendix

The jetty was originally constructed to a length of 82 meters but was lengthened in 1911-12 to 207 meters to allow for vessels of greater draught to access the wool supplies. The jetty continued to be used as a hub in the wool industry until 1954 when its commercial use came to a close. The Jetty continued to be used for non commercial activities such as fishing and boating until 1979 when it was badly damaged by fire. It was added to the state heritage register in 1983 and refurbished in 1986. (Khan 2006)

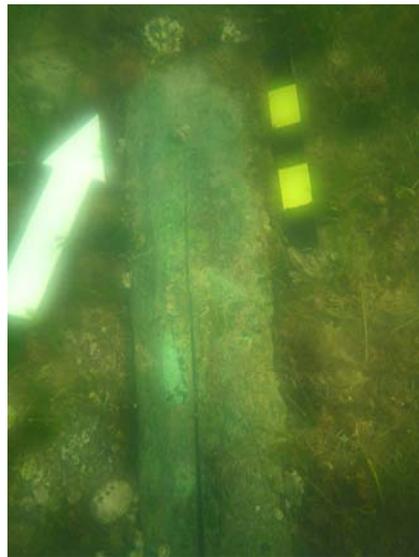
Figure 11. Plank with green paint matching traces on the jetty

The survey also uncovered evidence of the evolution and decay of the jetty itself. Close investigation of the jetty revealed areas with remnants of green paint, the survey of the area underneath the jetty uncovered a timber with the same colour of paint attached to it (figure 11). Another example of construction and or degradation associated artefacts can be seen from the cement covered bolt recovered for illustration and photos (see figure
