The *Mary Ellis* Report

Team 2

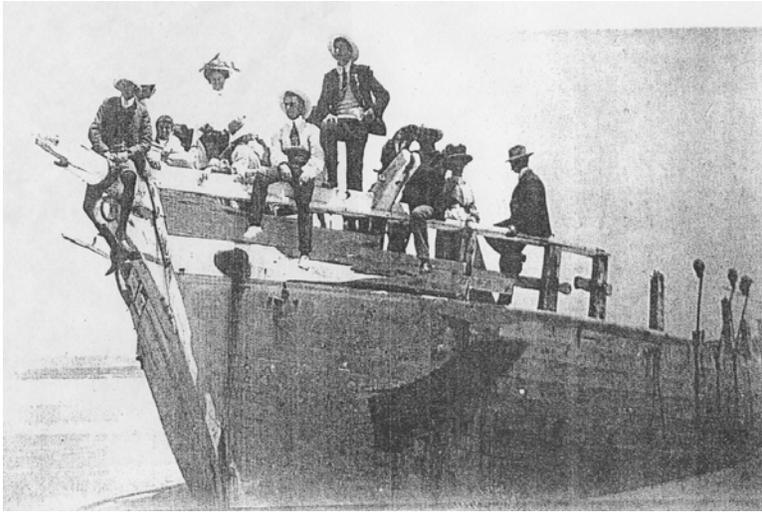
Although all hands were saved, the vessel was a total loss (Figure 2).

Figure 2. *Mary Ellis*. Image Courtesy: Axel Stenross Museum.
